REFERENCE	BT_2013_X98CUP_01_UK
DATE	2013 March 21st
SUBJECT	Brake fluid reservoir cap

CONCERNED : 2013 EURO CUP CLIO

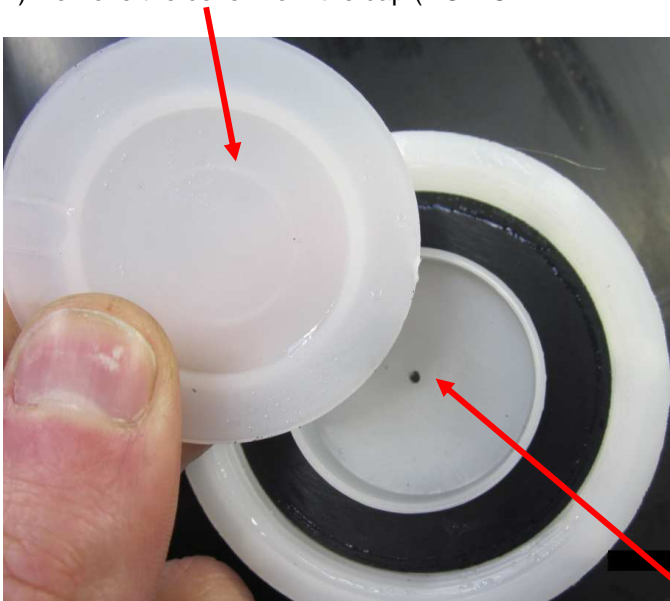
Renault Sport has found some brake fluid reservoir caps not drilled. The first cars delivered last week and this week may be concerned.

You must check the presence of a $\varnothing 2\text{mm}$ hole in the center of the cap.

1) Remove the cover from the cap (DO NOT DRILL THE COVER)

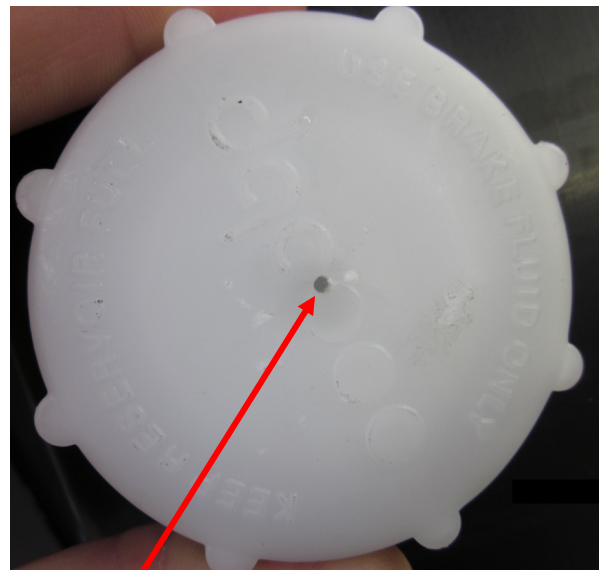
The Presence of this hole is **mandatory** for evident safety reasons.

2) Drill a $\varnothing 2\text{mm}$ hole in the center of the cap
Make sure that no plastic chip stays in the cap before re fitting
