CLIO R3T
EUROPEAN TROPHY

CLIO R3T

REFERENCE	BULLETIN TECHNIQUE N°3 / TECHNICAL NEWS N°3
DATE	08 / 09 / 2014
SUBJECT	Conduit Admission / Intake duct
PART

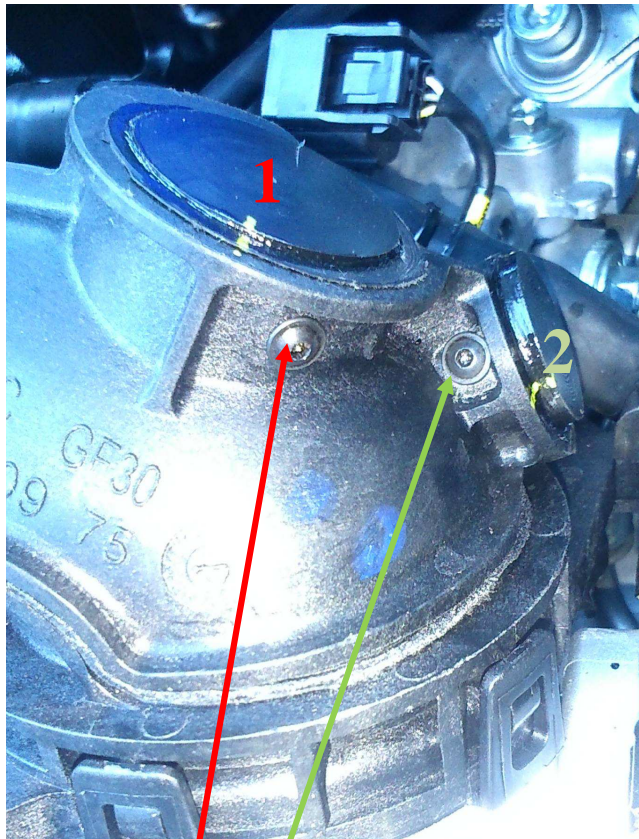
Suite à un défaut fournisseur, nous tenons à vous communiquer les informations suivantes :

Les bouchons de fermeture (1 et 2) sur le plénum admission présentent un défaut de collage. Nous vous demandons donc de maintenir ces bouchons par :

- Bouchon 1
 - Vis BHC M3 x 20
 - Quantité : 2
 - Localisation : Voir photo + en opposition

- Bouchon 2
 - Vis BHC M3 x 25
 - Quantité : 1
 - Localisation : Marquage Vert sur photo

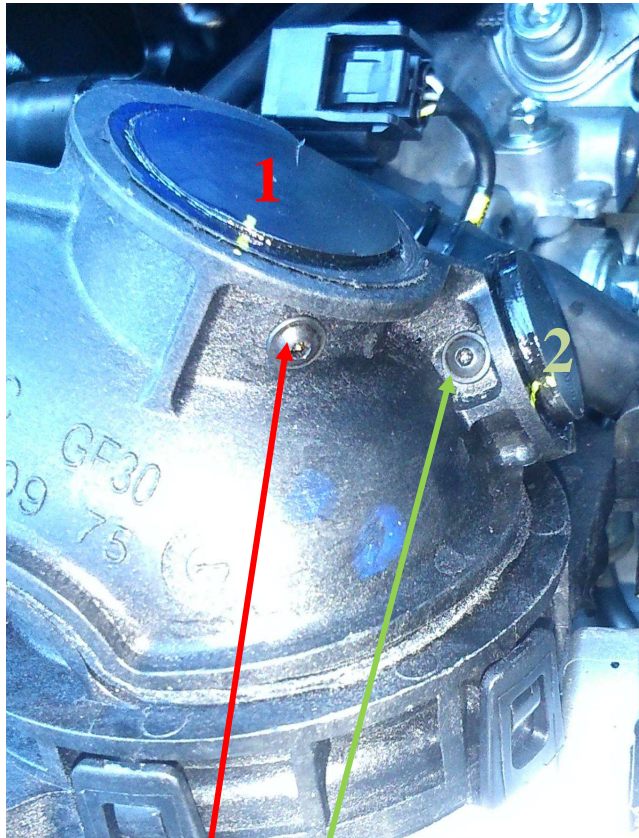
Following a supplier default, we would like to inform you about the following information:

The 2 corks on the intake duct present a default. We recommend to add screws in order to maintain the cork in position:

- Cork 1
 - Screw : BHC M3 x 20
 - Quantity : 2
 - Location : see picture + opposite side

- Cork 2
 - Screw : BHC M3 x 25
 - Quantity : 1
 - Location : Green marks on the picture
